Structural Report

Groudle Glen Wheelhouse
Groudle Glen
Onchan
Isle of Man

Curtins Consulting Ltd

25th October 2013

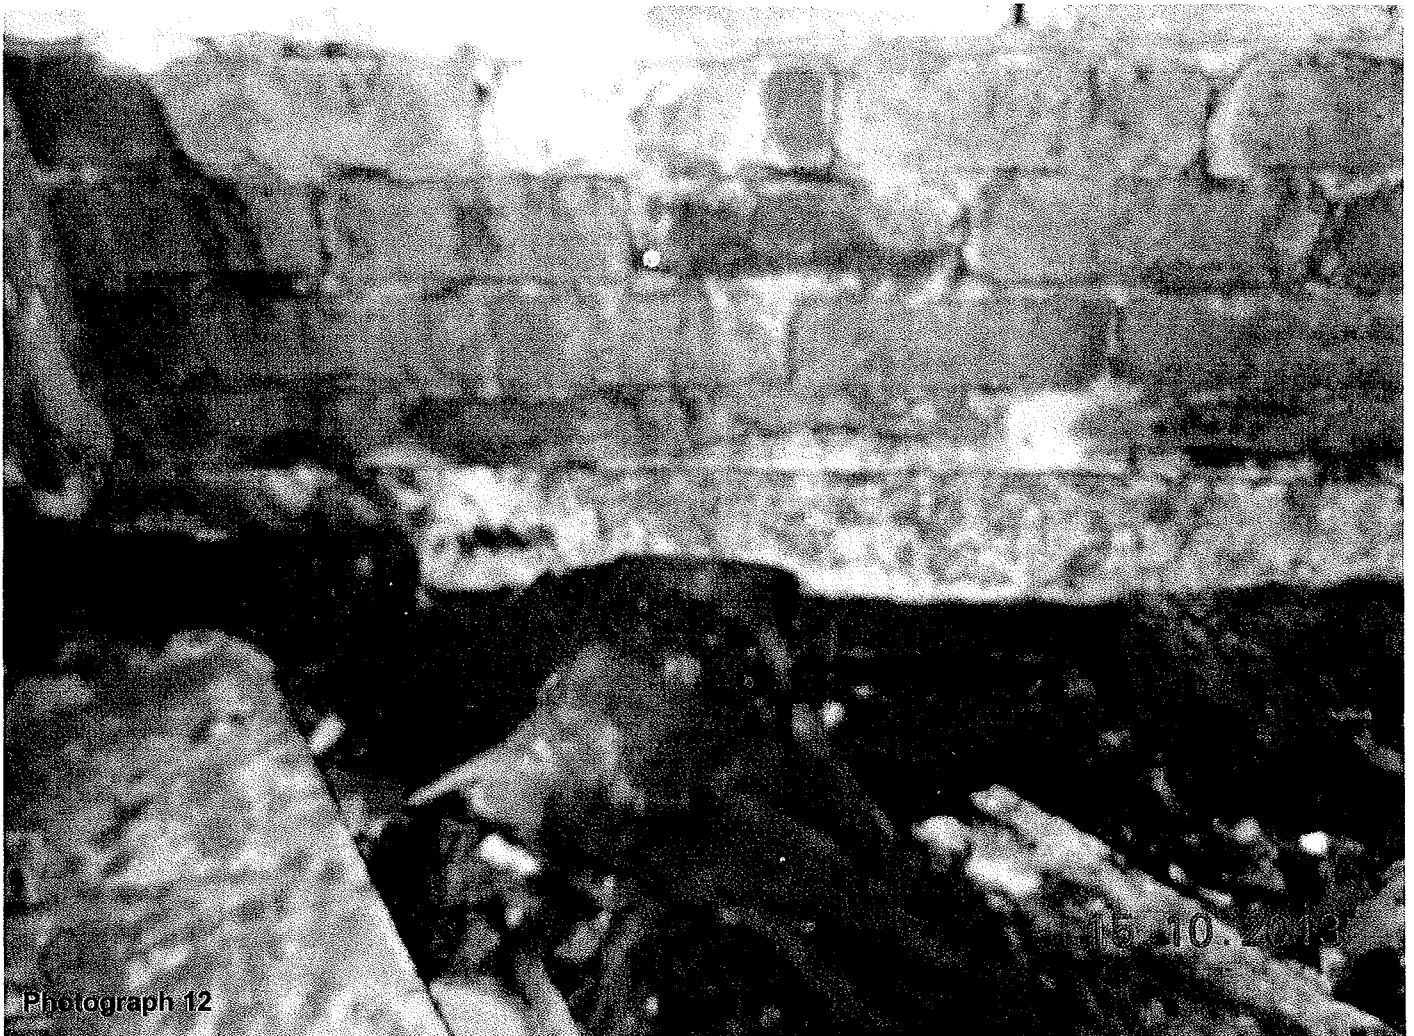
Photograph 12

The steel beam visible below the external walls exhibited significant corrosion, refer photograph 12.

The Wheelhouse is founded on steel beams, which exhibit extensive corrosion, with one beam close to a state of collapse.

- Prevent persons accessing the Wheelhouse including the ground floor external deck, until repair works have made the structure safe.
- Undertake a feasibility assessment in conjunction with a suitably experienced building contractor with regard to underpinning the wheelhouse, replacing the steel beams and beam foundations.

- If the above assessment is feasible, undertake the above work.
- If the above assessment is not feasible, the Wheelhouse will need to be dismantled and rebuilt with new steel beams and foundation.
